Document Title		Management Plan: Rehabilitation			
Document ID		Version	Issue Date	Review Time	Review Date
HGM-ENV-MPL-001		5	20 May 2024	12 months	May 2025
Approver Role	Approver Name	Approver Signature		Doc. Owner	Owner Name
GM Hillgrove	M.Varvari	 		HSEC Sup't	K.Bryant

1. PROJECT BACKGROUND

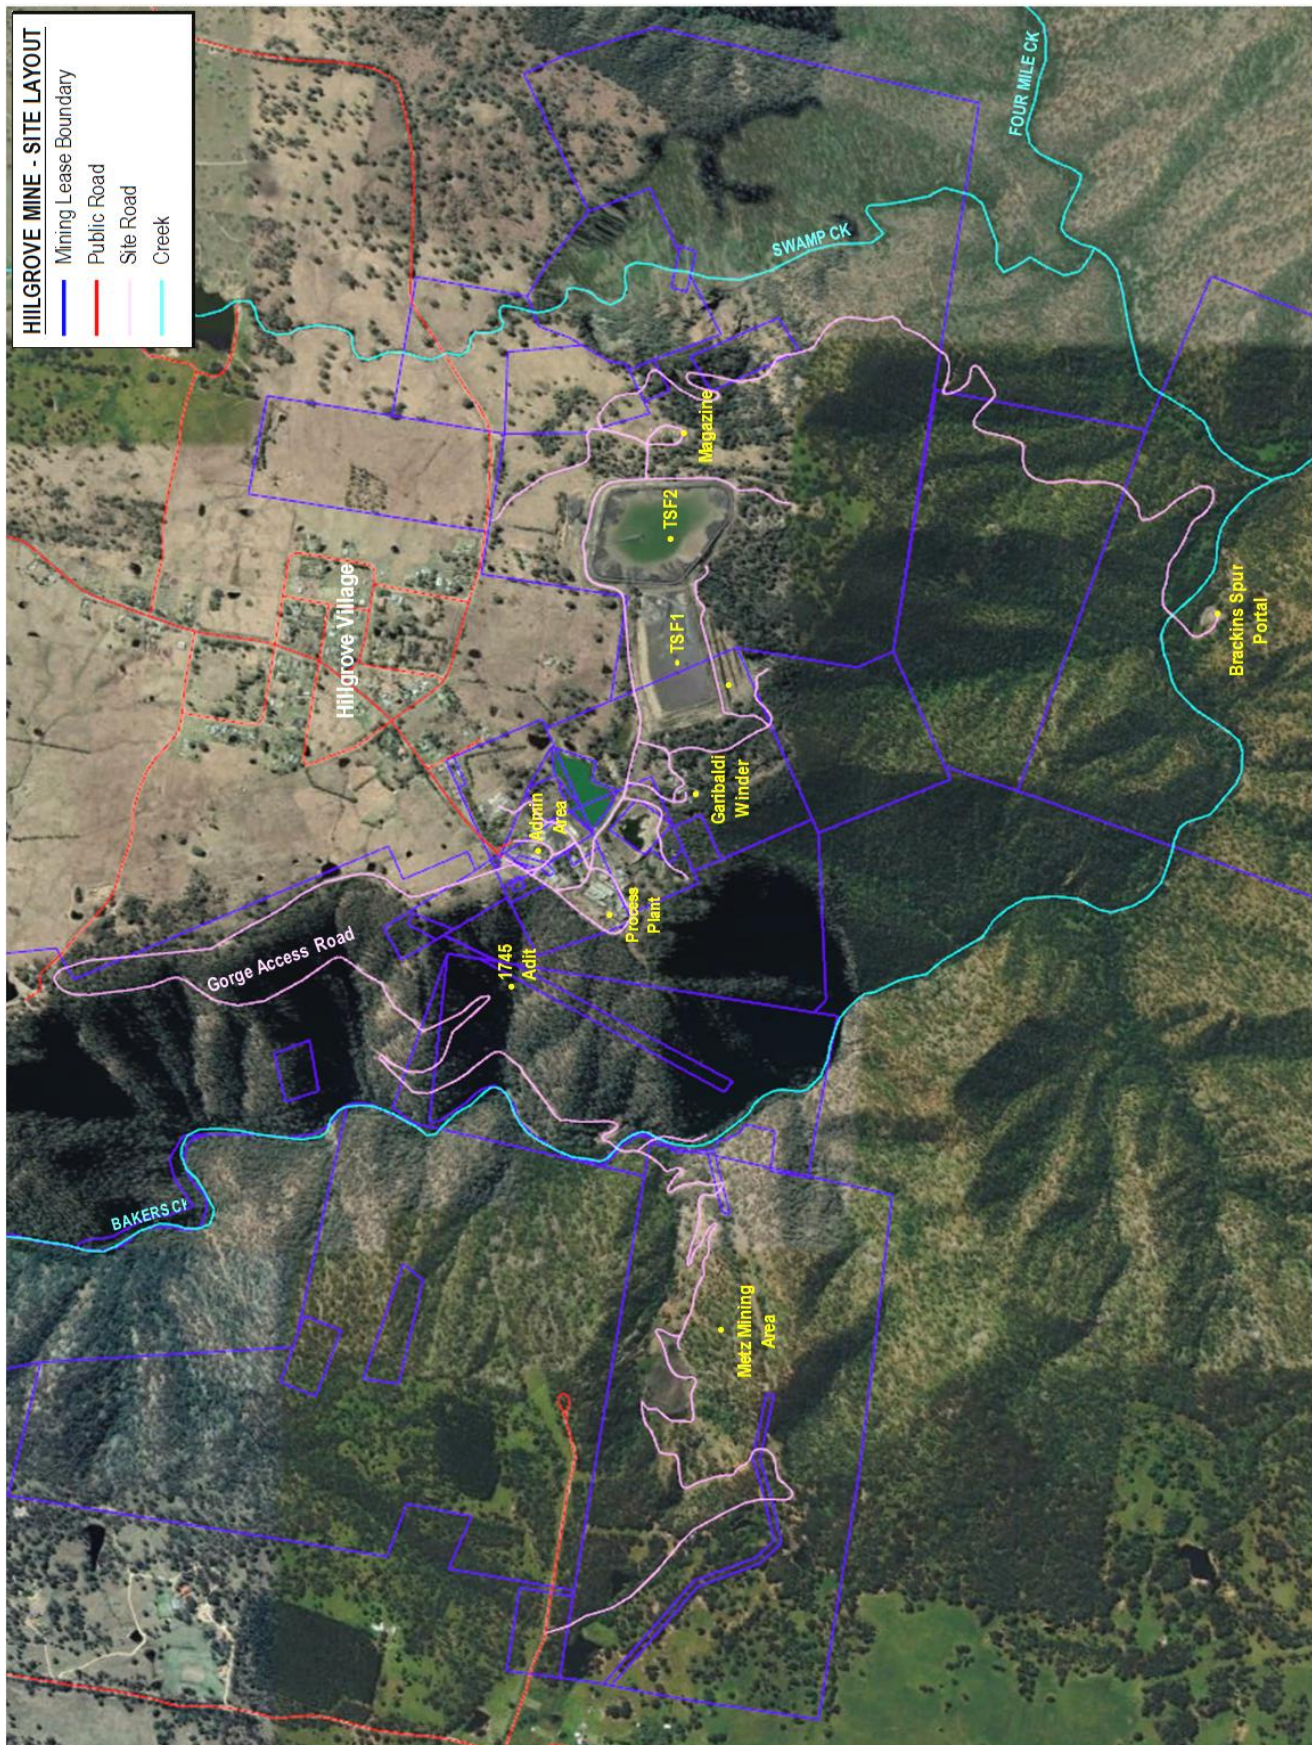
Figure 2: Operational Locations

Operational areas around the site are shown in Figure 2.

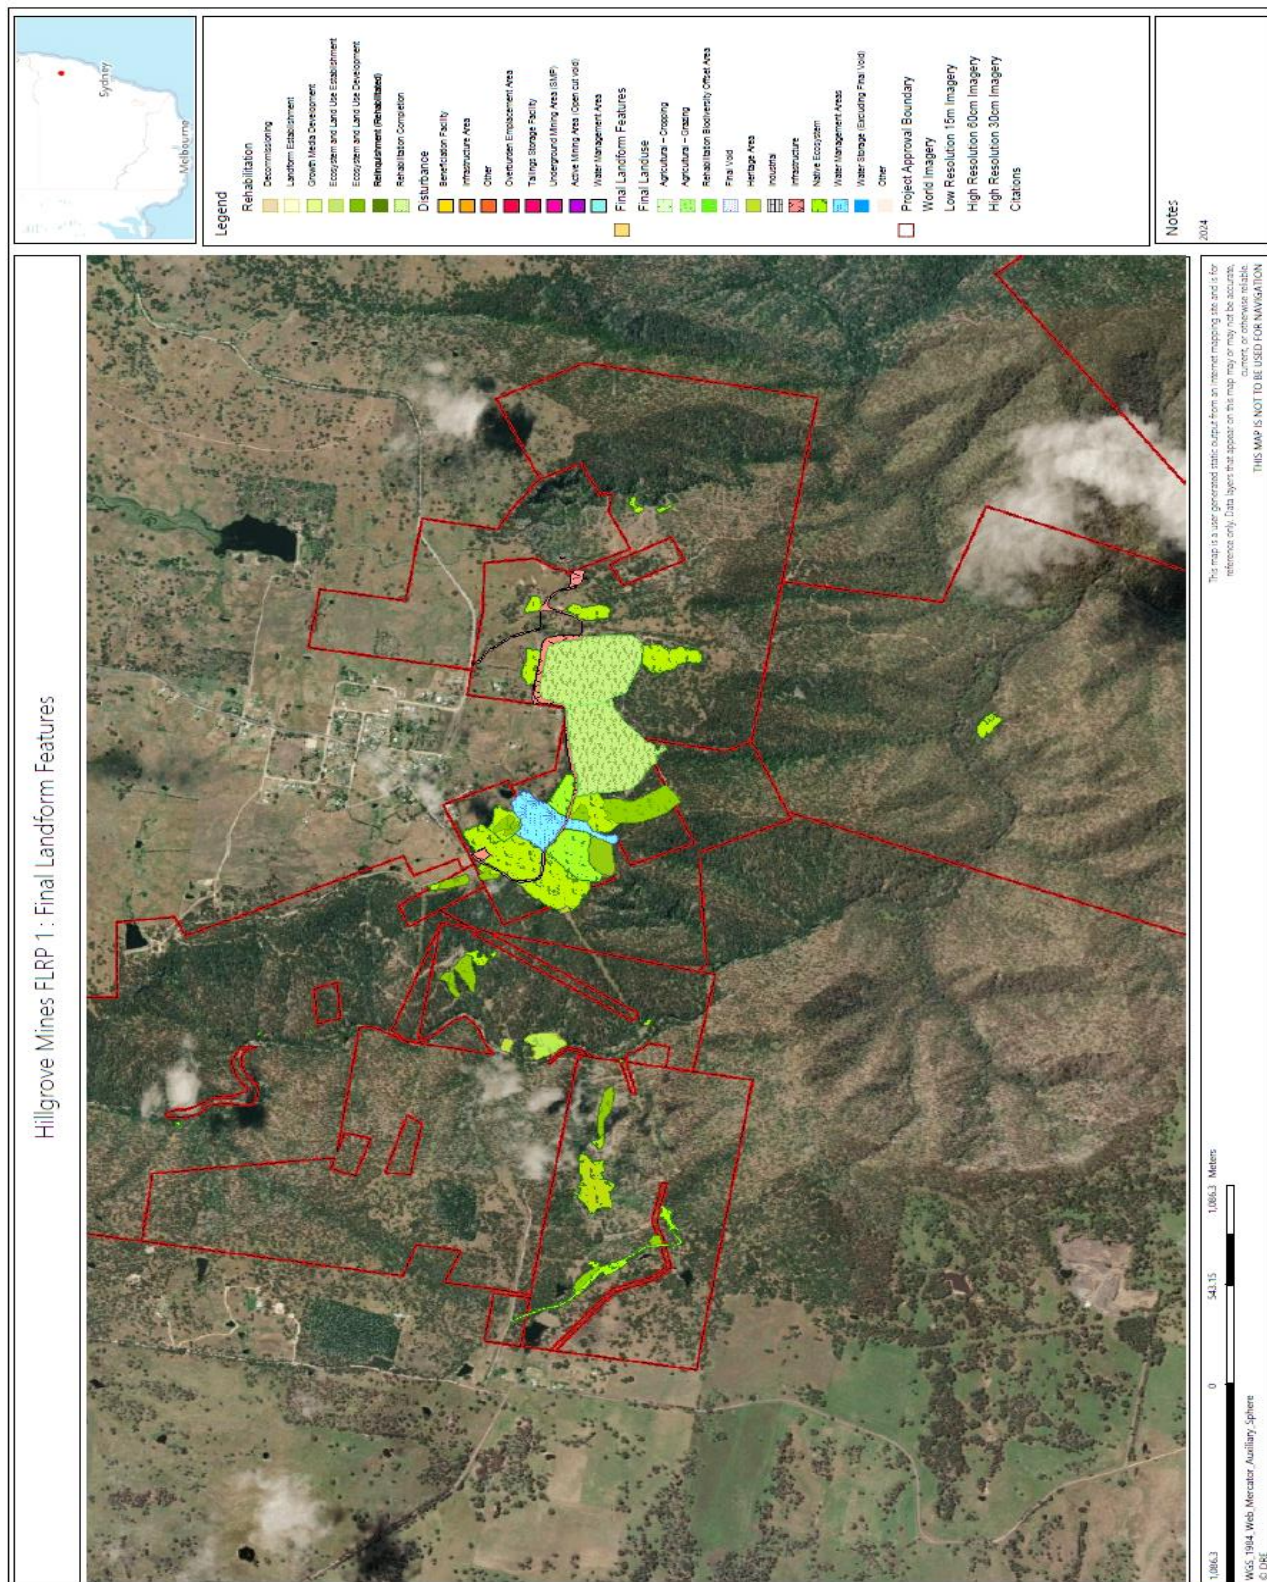
Figure 8: Final Landform and Rehabilitation Plan

5.1 Final Landform and Rehabilitation Plan
